CMR 169 07-08-01

Durham Light Infantry Museum & Gallery - A review of suitability for use for permanent storage and display of archive and object collections

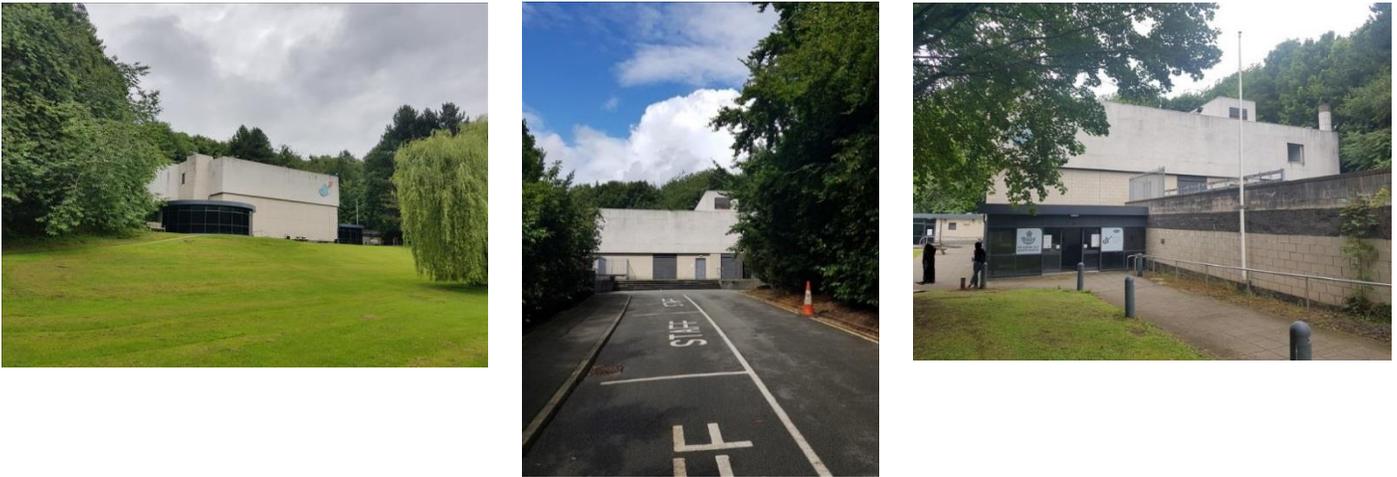
Figures 1., 2. & 3. Views of Aykley Heads including loading entrance, formerly glazed public entrance.

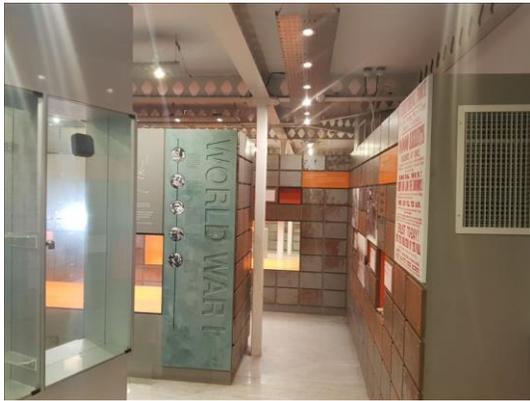
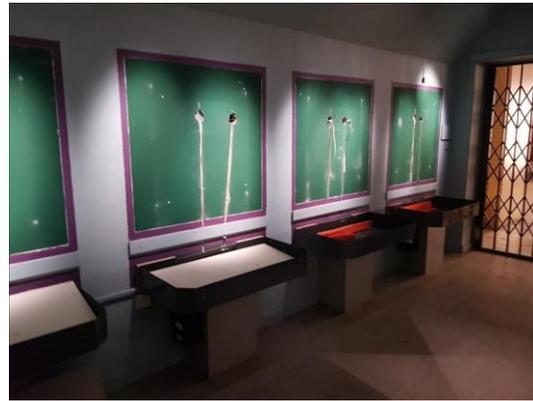
3.3 The display facilities on the lower ground level are now empty and partly dismantled (see figures 4. and 5. below). The cases have no internal climate buffering facilities ('gel trays') that would otherwise permit stabilisation of RH inside them, something that is standard nowadays. The larger of the cases present risks to staff in requiring very large sheets of glass to be removed in order to access the vitrine (the space inside a display case). The cases are lit internally with fluorescent strip lights. It was reported that access to alter the lighting was challenging, being from the top of the wall panel/case structure. Spotlights in the ceiling complement the case lights and the bulbs appear to be LEDs. The whole display area is run down and partly dismantled. The absence of seals and of the capacity to buffer cases means that they could no longer be used to display heritage safely. It is likely that an air conditioning system, with vents visible in the ceiling, was relied upon to try to control temperature and RH of the whole room, rather than fitting modern standard display cases. Interviews with staff including those working in the years before closure in 2016, revealed testimony such as:

Figures 4. & 5. Old display areas at Aykley Heads, including dismantled medal cases.

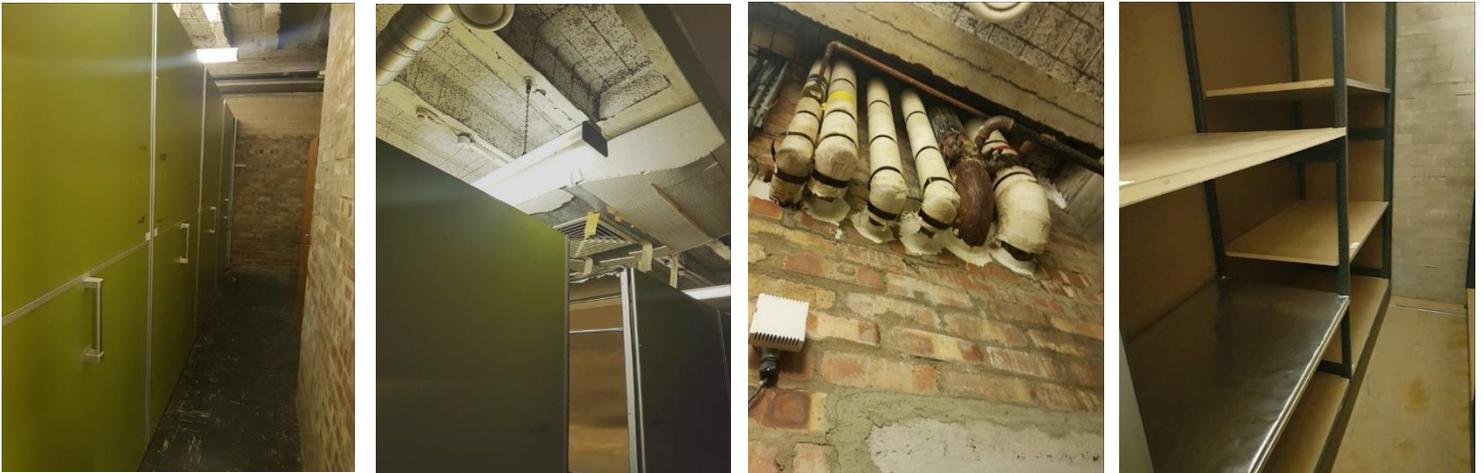
3.5 The store areas were also inspected for this report. One of them, formerly used for objects, textiles and some framed items, leading off from the workshop space, is in a dilapidated state. The large format mobile racks are constructed from chipboard and hardboard on a light steel frame. No aspect of the equipment meets the current standard for heritage shelf equipment (ref. BS 4971:2017 section 5.6). Heating pipework that runs through the workshop was routed through the store wall into the store in order to then be directed upward, to avoid a steel joist near the wall on the workshop side (instead of routing it up before the joist) and so would have constantly affected the internal climate. The environment was supposed to be managed using the ventilation systems and the ductwork for this, with degrading joints and insulation, is clearly visible. The walls appear to be single skin brickwork and the door does not fully seal and provides low attack resistance and minimal fire resistance, well below that required by the current building standard (ref. BS EN 16893 chapters 6 and 7). The store room now could not be used as a store without a new, fire, security, air-tight membrane and waterproof construction built inside it. Being on the first floor it would not be the optimum for a low energy store, benefiting from an uninsulated floor slab. No aspect of this room currently meets BS EN 16893 standards and storage of firearms in this room may be prohibited without greater security protection.

3.6 The capacity of this store is insufficient for the object collections, although if more were on display on a rotation elsewhere in the building this issue might be ameliorated. A second store, in better general condition but with no racking, also leads off the workshop. It is small, c. 3m x 5m maximum, and would provide only limited further capacity if fitted with racking. A pier towards one corner reduces workable space for racking. It is constructed in the same way as the first store and similarly would need an internal construction to provide the standards required but this would reduce its capacity as a store even more. There has been a suggestion that it might house the DLI archives but at the moment it is not only too small but is so far away from meeting the standards that without substantial investment it could never achieve Accreditation. The archives were specifically moved out of this building in 1998 for this reason. They have doubled in quantity since. If the DLI museum site were to be used to store collections, the only practical approach would be to construct a new store elsewhere within the envelope of the building.

Figures 6., 7., 8. & 9. Views of the objects store, racking, ductwork, wall and pipework.

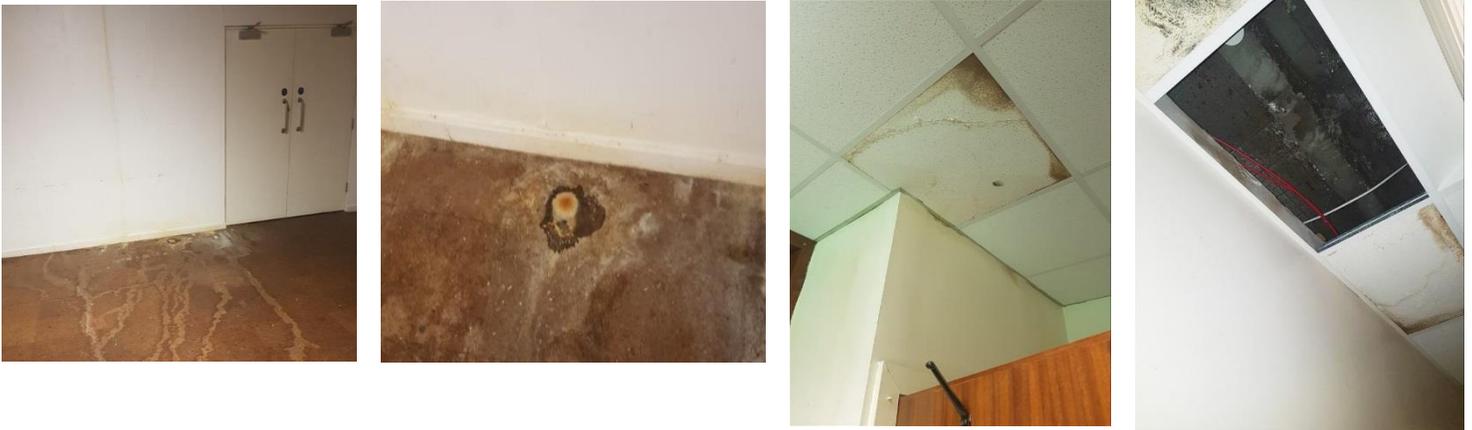
Figures 14., 15., 16. & 17. Examples of persistent historic water penetration problems (see 3.6 above).

3.8 The building was apparently plagued by roof leaks from the time it was built; it was re-roofed twice between its construction and closure. In addition, one leak overnight caused by failure of the air conditioning equipment ran through the ventilation ductwork and was so extreme that water poured out of the building when staff opened up the building in the morning. Some leaks were so persistent that they have resulted in deterioration of the internal fittings and even the build-up of calcite deposits (the beginnings of a stalagmite, see image above). The signs of leaks are visible everywhere throughout the building, with stains on the floors, down the walls and in suspended ceiling tiles. These are not recent stains, since closure: they present evidence of the structural weakness of the roof and possibly also of the concrete and steel frame itself. This in turn has led to high moisture content through parts of the building and fungal infections on woodwork for example. The large single glazed windows would have contributed to this in winter when the heating was fully operational, with condensation running down the window panes, rotting the sills and resulting in a build-up of fungal and other biological activity such as moss and lichen *inside* the building (see images above).

3.9 These problems are not insurmountable. With substantial investment the building might be re-usable for cultural events and short term temporary exhibitions, both of art and of historical material, including relating to the history of the DLI. The problems of the leakiness of the concrete envelope need to be investigated and resolved (if indeed they can be resolved) and the internal contamination cleaned up. There are asbestos floor tiles in several areas of the building which may need to be removed. The old displays need to be stripped out and the windows and frames will need to be removed and replaced with modern, double-glazed and secure units. It is possible that the heating pipework will need to be removed, the air conditioning system and infrastructure needs to be stripped out and the old oil-fired boiler is no longer suitable for a low carbon trajectory. All of these things can be done to make it a publicly accessible site, but only at a considerable price. Those 'envelope' works would be essential before beginning to plan for internal structural additions to permit long-term storage and use of priceless heritage collections. The cost of making it an accessible and economic cultural venue, without stored collections, may be in the region of £2-3million depending on the findings of a structural building survey and the level of quality of finishes and facilities. Currently much needs to be stripped out and it may be more cost effective to hollow out the building where it can be, address any structural issues and construct new internal spaces. As long as galleries can be made secure with an internal security partition at ground level, it may even be possible to re-instate the more attractive glazed walls at entrance level.
