Wolsingham Byway 157

Summary of inspections including photos during period of Experimental Traffic Regulation Order Sep 2016 to Oct 2017

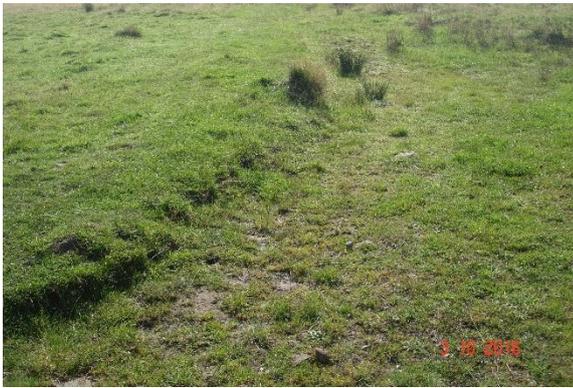
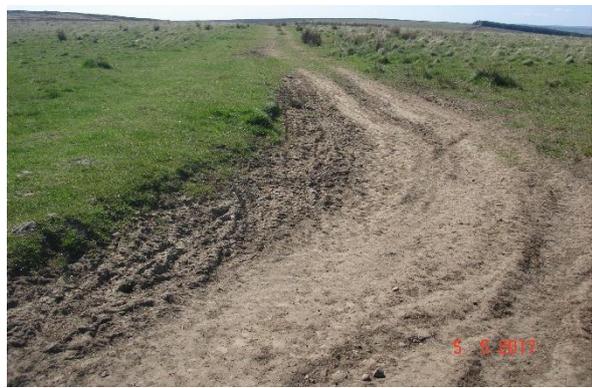
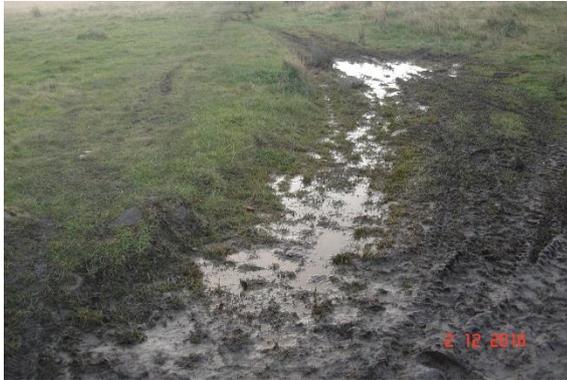
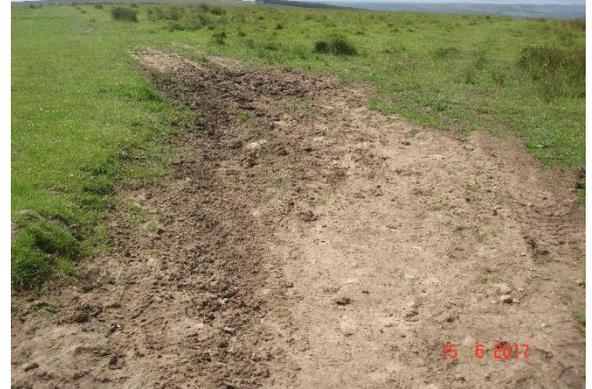
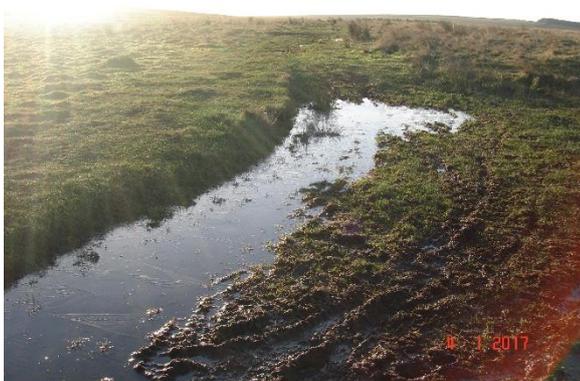
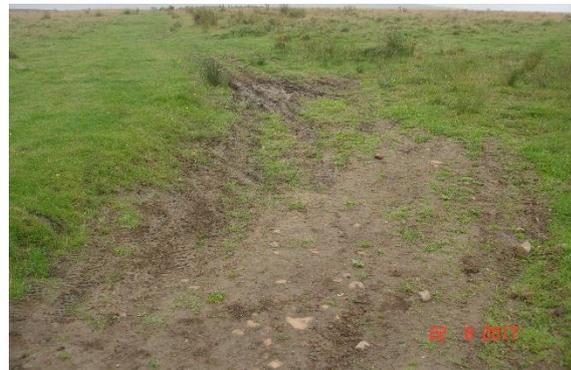
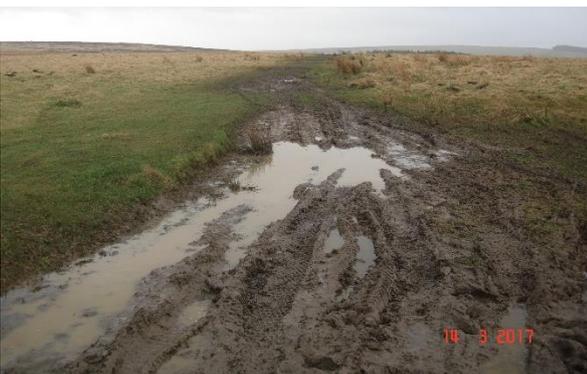
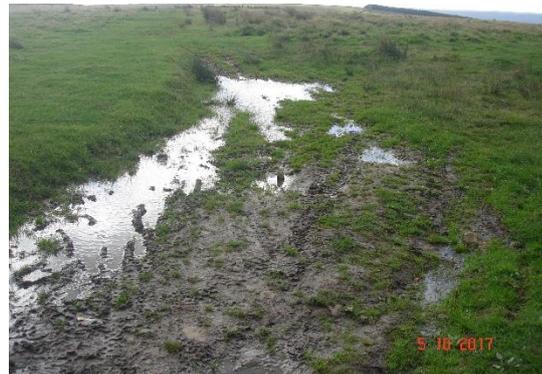
1. Start of Link 1 at Salters Gate – just inside gate

Nick	04 Jan 2017	Ground overall is soft, muddy and very sticky in many places. Waterlogging and standing water most with layer of ice found all along the byway. Strong evidence of two wheel motorbikes identifiable through the linear ruts. Worst sections for disturbance are Salters Gate gate#1 and first 30m of the Link #1, northern approach to culvert #1, multiple areas on 90 Acre allotment in particular southern side of gate #5, slopes down and up from culvert #3, and the rushes. Quad bike use along Link#4 and Link#5 includes riding off byway onto wide moor presumably gamekeeper related. Links #9 and 10 is cattle poached and evidence of tractor with trailer movements.
Audrey	1 Feb 2017	Worst section remains to the south of Sand Edge due to agricultural movements. Key weak spots remain including the culvert at 90 Acre and its approaches, the marshy (rush) section at the southern end of 90 acre and the culvert on the top moor. Other stretches also with particularly deteriorating surface include the initial section at Salters Gate, after gate 4 and most of 90 Acre. Minimal evidence of horse and mountain bike, some pedestrian but largely 4W vehicular damage to surface the factor impacting the path's surface. 2W use evident but less obviously damaging. As a pedestrian a bit of a trudge.

Nick	14 Mar 2017	Worst section is now Link#2, particularly the approach to culvert #1 where the now liquefied surface is a quagmire due to tractor movements. Key weak spots are gate #1 gateway, culverts #2 and #3 as well the start of Link #5 after gate #5 and the rushes at the southern end of Link #6. Standing water remains the same but ground is looking drier in many places including the south end of Sandedge through Links #9 and #10. Evidence of all users expect boot prints. Tractor, quad and motorbike damage the factor impacting the path's surface.
Audrey	05 May 2017	Whole route dried out considerably since previous inspections following a prolonged warmer period of little or no rain. The most churned up and uneven sections around culvert #1(link #2), descent to bottom of 90 Acre northside (to culvert # 3 on link #5), rushes section at south end of 90 acre (end of link #6) and the longstanding deep ruts at start of link#8 Sand Edge. The southern end which had a film of mud during the winter is completely dried out and mainly level 'cos of stones/bricks on surface. Easiest to walk since the autumn.

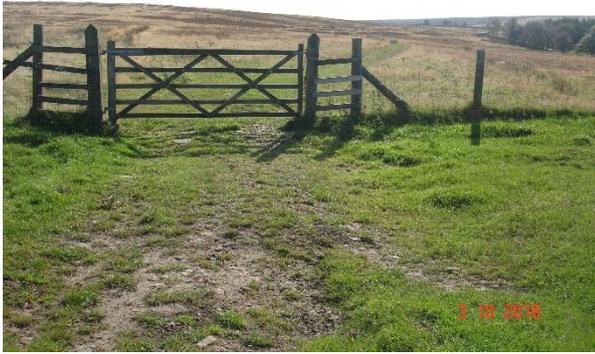
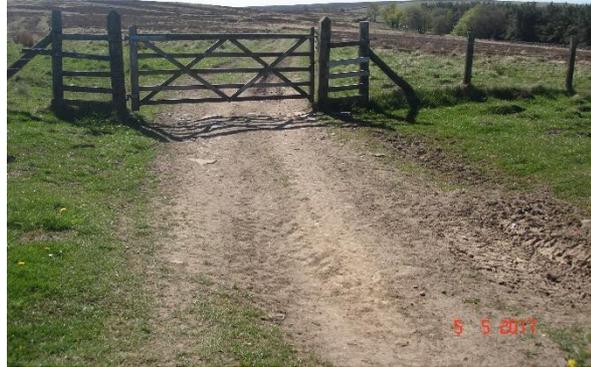
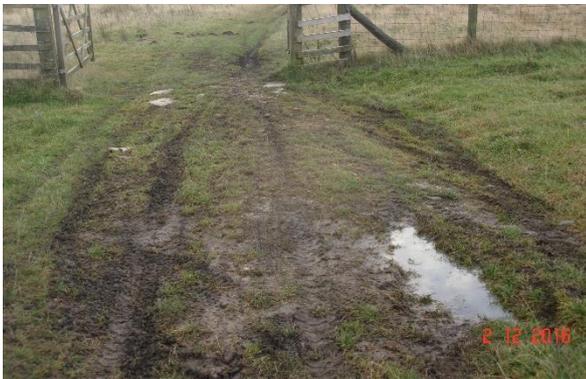
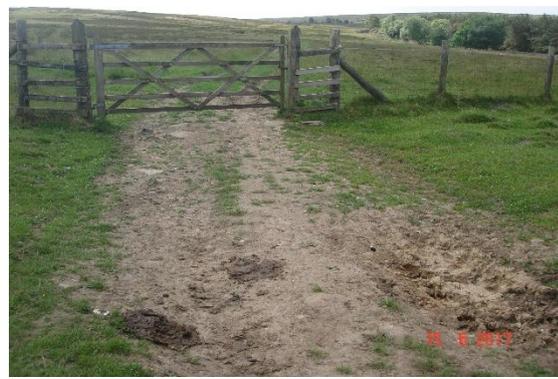
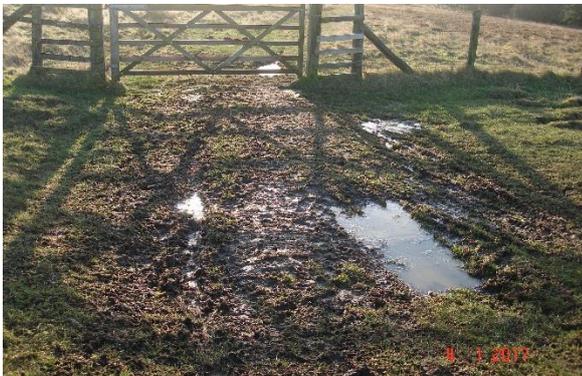
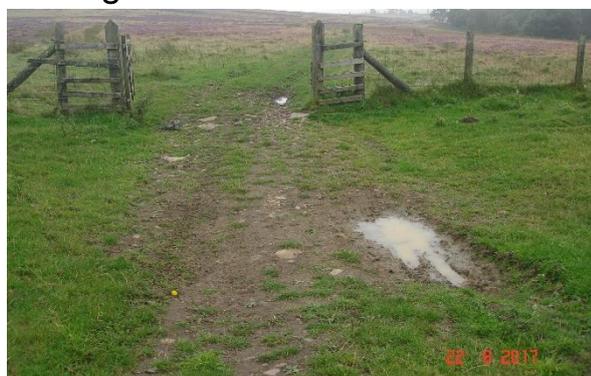
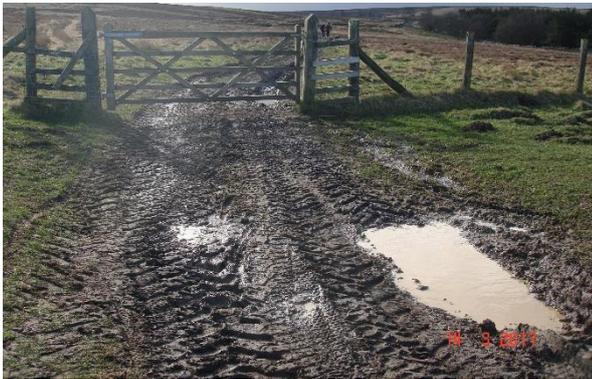
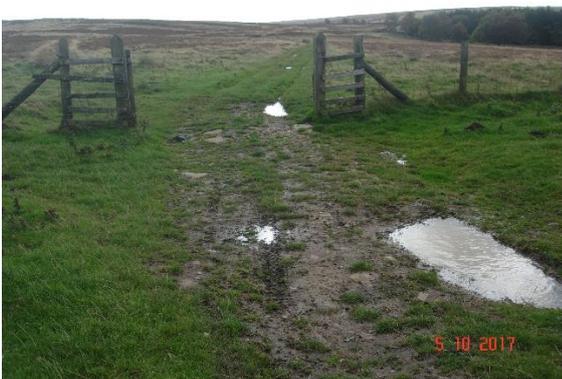
2. Start of Link 2 at Gate 2

Audrey	15 June 2017	Whole route still dry although ground a little damper than previous inspection following 2-3 weeks of sporadic rain. Area has greened up with summer growth. The most churned up and uneven sections around culvert #1(link

#2) has standing water again, descent to bottom of 90 Acre northside (to culvert # 3 on link #5) still bare with 4W rutting and 2W imprints, rushes section at south end of 90 acre (end of link #6) and the longstanding deep ruts at start of link#8 at Sand Edge. Still standing water in 2 of the 3 depressions here. The southern end remains dried out and mainly level.
Audrey	22 Aug 2017	Whole route has further greened up although the ground softer than May and June inspections due to more rainfall including drizzle/fog at the start of the inspection. Minimal change throughout. Culvert #1 and its approach is still solidly 4WD rutted and damp with some standing water, as is the approach to 90 Acre culvert #3, the rushes at the south end of 90 Acre. Motor bike imprints not avoiding these areas quite so much as during the winter when wetter.
Audrey	5 Oct 2017	Ground damper again as the weather has become colder and with an average amount of rain for time of year. Culverts crossings continue to be the most damaged areas especially the top moor culvert #1 with multiple parallel ruts on its approaches with standing water and the 90 Acre #3 which is more clayey/slippery with multiple depressions. Top of 90 Acre rushes area deep ruts still with standing water. More 'middle' rut developing (between the 4WD ruts) in 90 Acre and before culvert #1. The southern end from Sand Edge southwards seems to be little changed and appears more robust with the more sandy surface on the moor and the farmland stretch being stone/brick surface. The tractor trailer movements over the winter are evident again but surface seems robust here.
